PIOTR STRZAŁKOWSKI<sup>1</sup>, MAREK JENDRYŚ<sup>1\*</sup>**ENVIRONMENTAL HAZARDS ASSOCIATED WITH MINE SHAFT CLOSURE:  
A PRACTICAL AND COMPUTATIONAL CASE STUDY**

**Keywords:** Environmental hazards; mine shaft closure; numerical simulations

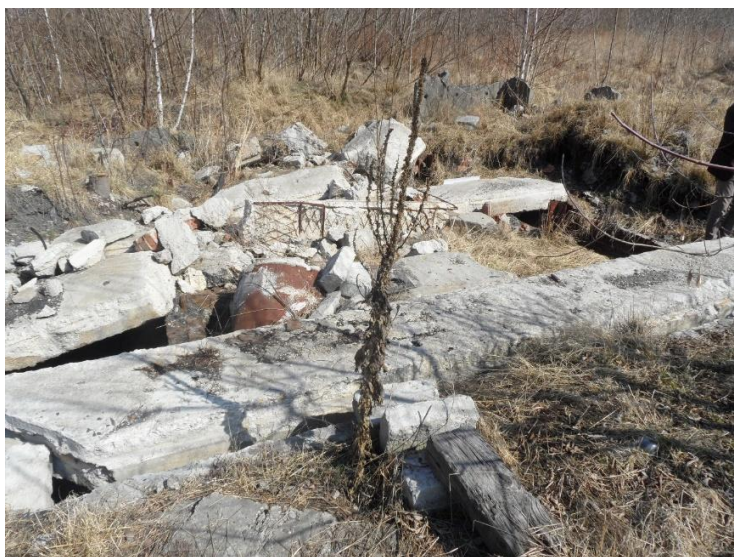
After approximately 20 years, the slab was destroyed, and reinforcement made from rails was partially stolen. Fig. 4 shows the slab condition from that period.

Fig. 4. View of the destroyed shaft capping slab P

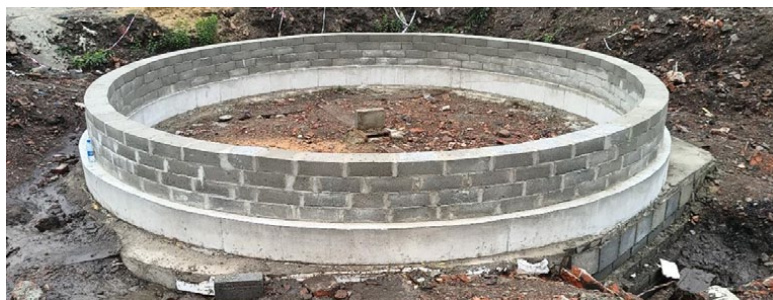
Remedial work began by replacing the brick masonry lining at the collar. The new lining was constructed from precast concrete shaft blocks, as shown in Fig. 10. The backfill was topped up with rubble. Subsequent work followed the arrangement shown in Fig. 1. A reinforcing masonry collar was constructed with a width of 0.7 m at a depth of 1 m, and the lining near the collar was replaced. A reinforced concrete slab 0.45 m thick in the middle and 0.40 m at the perimeter was constructed on a blinding concrete layer with a damp-proof membrane, according to the design [38].

Fig. 10. Reconstructed masonry lining fragment at the shaft collar

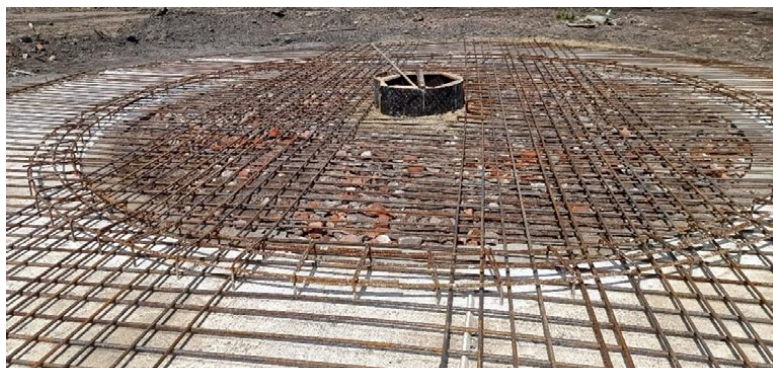
Reinforcement consisted of a double layer mesh of Ø16 bars at approximately 150 mm spacing – see Fig. 11. The slab incorporates a Ø900 cased opening for backfill level inspection and replenishment, and a gas vent nozzle – as in Fig. 12.

Fig. 11. Reinforcement of the slab sealing the shaft

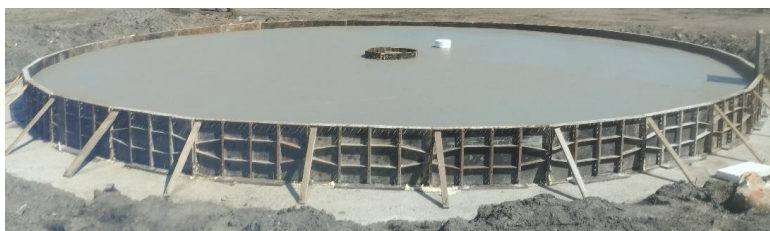
Fig. 12. View of the concrete slab

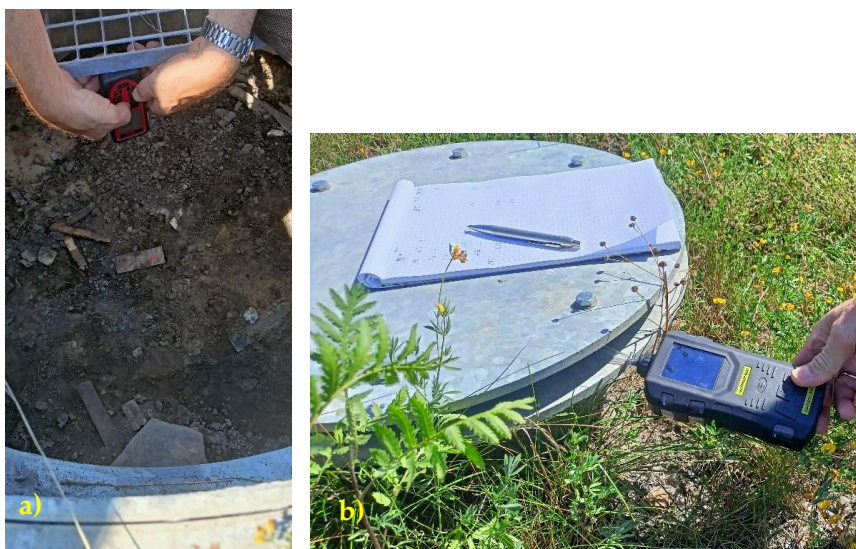
Environmental control includes routine inspections of the closing slab and measurement of backfill level, as well as determination of gas concentrations at the outlet of the vent pipe embedded in the slab (Fig. 13b) using an S316 pumping multi-gas detector. The backfill level is measured monthly and shows no changes exceeding the instrument accuracy when measured with a laser distance meter. For each reading, the cover on the pipe is removed, and the distance is read with the meter seated at the same reference point (Fig. 13a). Gas concentrations monitored include  $\text{CH}_4$ ,  $\text{CO}_2$ ,  $\text{CO}$ , and  $\text{H}_2\text{S}$ . Periodic measurements yielded average values:  $\text{CH}_4$  – 0%,  $\text{CO}_2$  – 230 ppm,  $\text{CO}$  – 0%,  $\text{H}_2\text{S}$  – 0%, indicating no gas migration through the backfill.

Fig. 13. Measurements: (a) backfill level; (b) gas concentration
