# ARCHIVES of FOUNDRY ENGINEERING

## Industrial Potential of Additively Manufactured H13 Steel Components: A Service Life Study

This article focuses on evaluating the service life of components made from H13 tool steel manufactured using additive manufacturing, specifically 3D printing. This was done by comparing them with components produced by conventional manufacturing methods. H13 tool steel is widely used due to its high mechanical strength and resistance to thermal cycling, properties which are particularly important in high-pressure die casting (HPDC) applications. In such processes, components are regularly subjected to significant mechanical and thermal stresses. The article provides a comprehensive comparison of dimensional stability, porosity, surface roughness, hardness, and operational wear in conventionally and additively manufactured H13 components. Additional measurements of surface roughness were conducted to provide further insight into the material's surface condition and the overall reliability of the additively manufactured components. The results provide insight into the advantages and limitations of additively manufactured H13 components and support their p

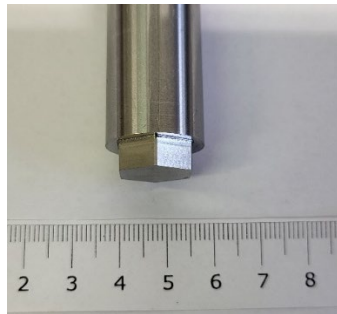
a) whole component                      b) detail of working part

Fig. 1. Geometry of the component used for both conventionally and additively manufactured variants

Figure 1a shows the complete component from which test samples were taken for the evaluation of mechanical properties. Samples were prepared from both conventionally manufactured and additively manufactured components for comparative analysis. The testing was carried out on the functional part of the component, which has a hexagonal geometry and is directly exposed to molten metal during operation. Figures 1a and 1b show the component geometry, which is identical for both conventionally and additively manufactured variants.

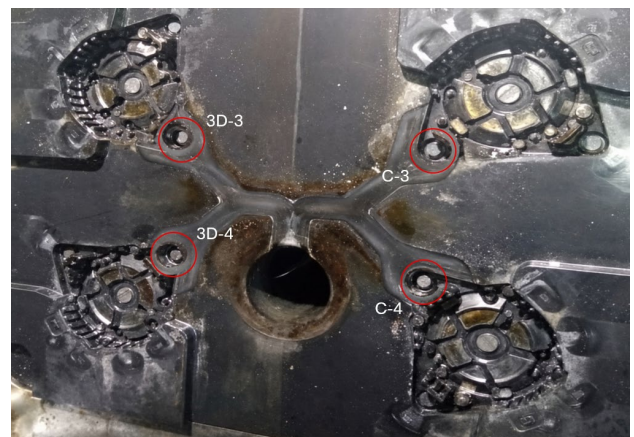
Fig. 2. Positions of the conventionally manufactured components C-3 and C-4 and the additively manufactured components 3D-3 and 3D-4 in the die-casting mould

All four components had the same geometry and were installed simultaneously at four different positions in the die-casting mould as shown in Figure 2. Thus, C-3 and C-4, as well as 3D-3 and 3D-4, differed in their positions within the mould. The designation C refers to conventional manufacturing, whereas 3D refers to SLM additive manufacturing. All components were made of H13 tool steel and had identical geometry and subsequent heat treatment, machining, and coating procedures. The conventionally manufactured components C-3 and C-4 were located in the upper-right and lower-right positions, respectively, whereas the additively manufactured components 3D-3 and 3D-4 were located in the upper-left and lower-left positions, respectively, as viewed in Figure 2.

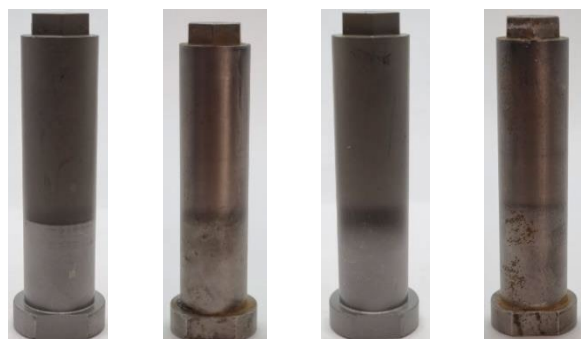
a) component C-3 before operational testing b) component C-3 after operational testing c) component C-4 before operational testing d) component C-4 after operational testing

Fig. 3. Components C-3 and C-4 before and after operational testing

Representative photographs of the conventionally and additively manufactured components before and after operational testing are shown in Figures 3 and 4 a, b, c, d.

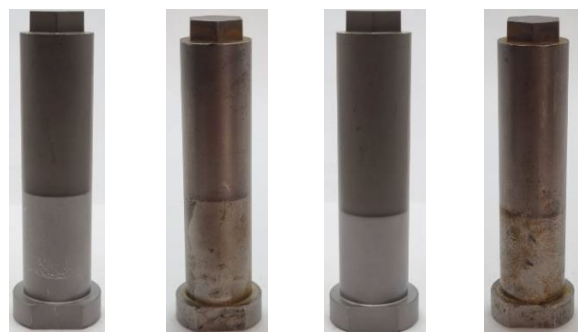
a) component 3D-3 before operational testing b) component 3D-3 after operational testing c) component 3D-4 before operational testing d) component 3D-4 after operational testing

Fig. 4. Components 3D-3 and 3D-4 before and after operational testing

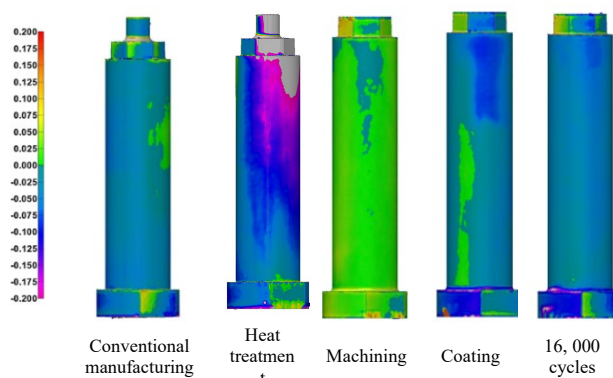
Figure 5 shows the results of 3D scanning of component C-3 in the individual stages of processing and subsequent operational loading. The colour scale indicates surface deviations, with blue shades representing minimal differences and red tones representing maximum deviations. In the first step, i.e., in the as-manufactured condition, the surface of the conventionally manufactured component was significantly uneven, with numerous deviations indicated by the purple areas. After heat treatment, more significant dimensional changes appear, which are particularly evident in the areas shown in purple. Machining largely eliminates these differences and the surface becomes uniform, as evidenced by the predominance of green tones. Coating further evens out the surface, and the resulting structure shows only minimal deviations. After 16,000 cycles, the surface remains stable and the changes are only local in character.

Fig. 5. First part of the technological process of component C-3

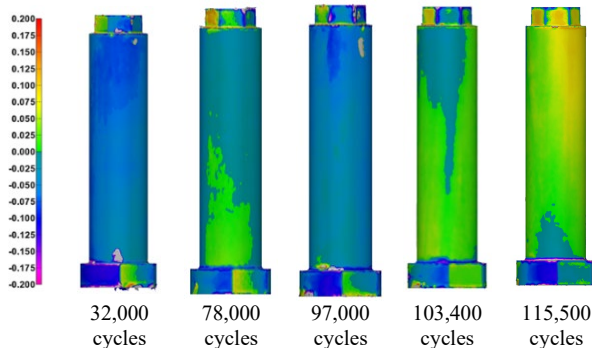
Figure 6 shows the results of 3D scanning of the surface of component C-3 after various numbers of operating cycles.

After 32,000 cycles, the surface is still relatively homogeneous with minor local changes. After 78,000 cycles, more significant deviations begin to appear, indicating a slight loss of material. At 97,000 cycles, these changes spread further and the surface becomes less uniform. After 103,400 cycles, more extensive areas with greater deviations are visible, indicating gradual surface wear. After reaching 115,500 cycles, surface degradation is already apparent over a larger area, which confirms gradual deterioration of surface properties under long-term loading.

Fig. 6. Second part of the technological process of component C-3

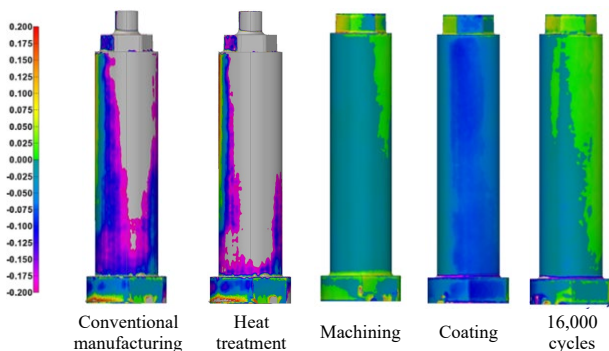
Figure 7 shows the results of 3D scanning of component C-4 at various stages of processing and after initial operational loading. After conventional manufacturing, the surface is significantly uneven, with numerous deviations shown in purple tones. Heat treatment further accentuates these differences, as evidenced by the presence of large areas with high deviations. Subsequent machining significantly unifies the surface and eliminates most of the unevenness, as can be seen in the predominant blue and green areas. After coating, the surface remains uniform with minimal local changes. After 16,000 cycles, the first signs of wear appear, but the surface remains largely stable.

Fig. 7. First part of the technological process of component C-4

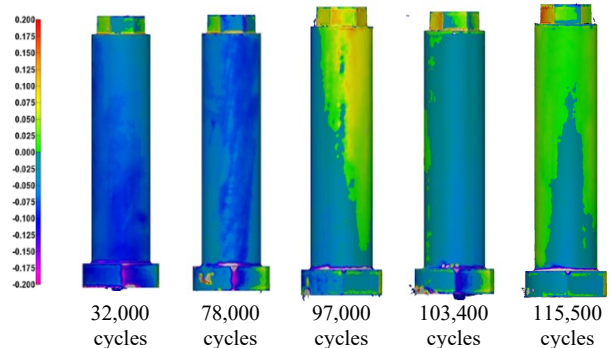
Figure 8 shows the results of 3D scanning of the sample surface after gradual loading during its life cycle.

After 32,000 cycles, the surface is relatively homogeneous with minor local changes, which are mainly visible at the bottom of the component. After 78,000 cycles, wear spreads but remains at an

acceptable level, and the surface does not show any significant degradation. At 97,000 cycles, larger areas with yellow tones appear, indicating a more significant loss of material and an increase in unevenness. After 103,400 cycles, these areas continue to expand and the surface begins to become noticeably uneven. After reaching 115,500 cycles, significant surface degradation with greater deviations is evident, especially in the upper part of the component, which confirms the gradual deterioration of surface properties under long-term operational loading.

Fig. 8. Second part of the technological process of component C-4

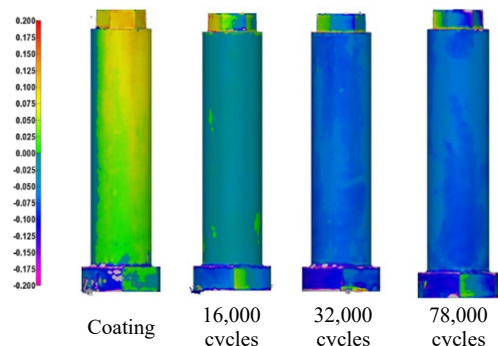
Figure 9 shows the results of 3D scanning of the sample after coating and subsequent loading at various stages of the operating cycle.

Immediately after coating, significant surface unevenness is apparent, especially in the upper part of the component. After 16,000 loading cycles, the surface becomes significantly more even and most of the area stabilises. This condition is maintained even after 32,000 cycles, when the surface is still uniform and shows no major signs of wear. Even after 78,000 cycles, no significant degradation is observed, and the surface remains largely homogeneous with minor local deviations, indicating good coating stability under long-term loading.

Fig. 9. First part of the technological process of component 3D-3

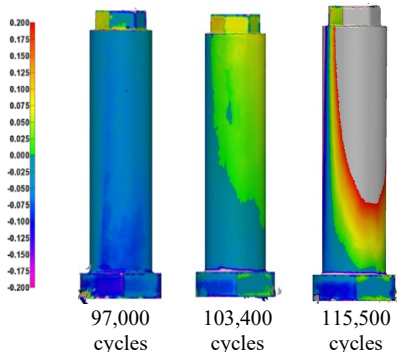
Figure 10 shows the development of the sample surface after long-term loading, after 97,000, 103,400, and 115,500 cycles.

After 97,000 cycles, the surface is still largely uniform. After 103,400 cycles, these areas expand further and the surface becomes

more uneven, indicating accelerating material degradation. After reaching 115,500 cycles, the surface is significantly damaged, indicating a change in surface geometry.

Fig. 10. Second part of the technological process of component 3D-3

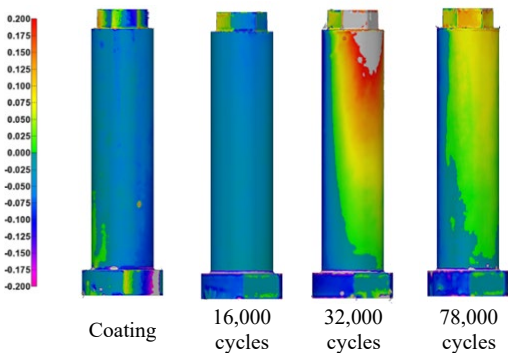
Figure 11 shows the results of 3D scanning of the sample surface after coating and subsequent loading at different numbers of cycles.

Immediately after coating, the surface is predominantly homogeneous, with minor local deviations. After 16,000 cycles, the surface still appears stable, with blue tones predominating and no significant changes apparent. However, after 32,000 cycles, extensive areas of red and grey tones appear, indicating significant surface wear and degradation, especially in the upper part of the sample. After 78,000 cycles, the damage spreads further and green-yellow areas confirm significant surface unevenness, indicating continued material degradation under long-term loading.

Fig. 11. First part of the technological process of component 3D-4

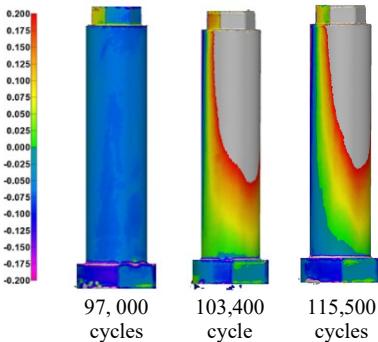
Figure 12 shows the results of 3D scanning of the sample surface after long-term loading, after 97,000, 103,400, and 115,500 cycles.

After 97,000 cycles, the surface is still relatively uniform, with blue tones predominating and only localised signs of significant wear. After 103,400 cycles, however, an extensive area appears that shows advanced surface degradation. After reaching 115,500 cycles, the damage spreads further, and a distinct red and grey area at the top of the sample demonstrates changes in surface geometry.

This condition can be considered the final stage of the sample's service life.

Fig. 12. Second part of the technological process of component 3D-4

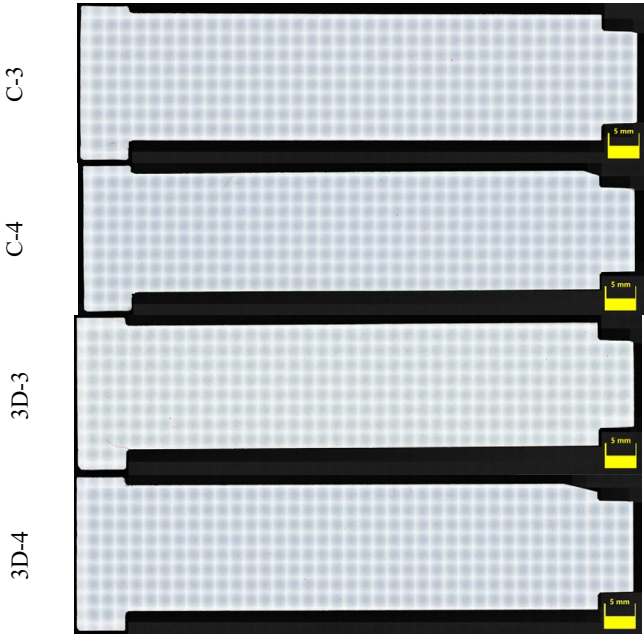
The measurement methods also included an assessment of micro-porosity in conventionally and additively manufactured components due to its impact on the mechanical properties of the material and the dimensional accuracy of the components. An example of porosity distribution in conventional and additive components is shown in Figure 13.

Fig. 13. Porosity distribution in conventionally and additively manufactured H13 components.

Table 4 shows the porosity values of all evaluated components. A porosity volume of 0.04 and 0.03% was measured in both conventional and additive components.

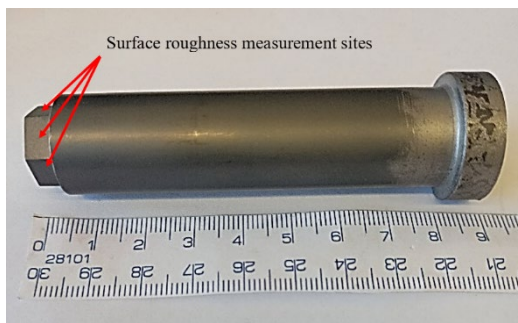
The red arrows in Figure 14 indicate specific areas on the crown where surface roughness measurements were taken. These locations were selected to represent the character of the surface created during the manufacturing process and to enable evaluation of the quality of machining or follow-up surface treatment and subsequent operational wear. The location of the measuring points on the crown ensures sufficiently accurate and repeatable results, which can then be compared with the hardness values or other mechanical properties determined on the same sample.

Fig. 14. Roughness measurement locations

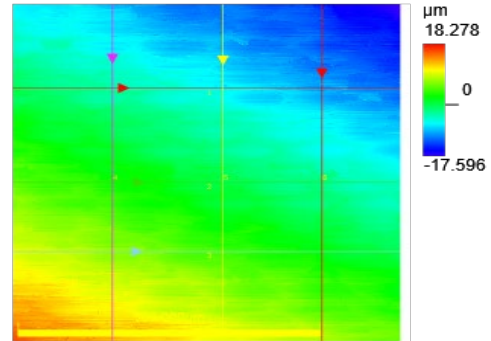
Figure 15 shows a colour map of the surface obtained using a confocal microscope, which captures the topography of the examined area. The colour scale on the right shows the height differences of the surface, from the lower parts in tones of blue to the highest peaks in red. The area is marked with arrows and

numbered areas where detailed roughness measurements were performed. These locations were chosen to represent different characteristic parts of the surface and to provide the most accurate picture of its actual morphology.

Fig. 15. Surface topography obtained using confocal microscopy

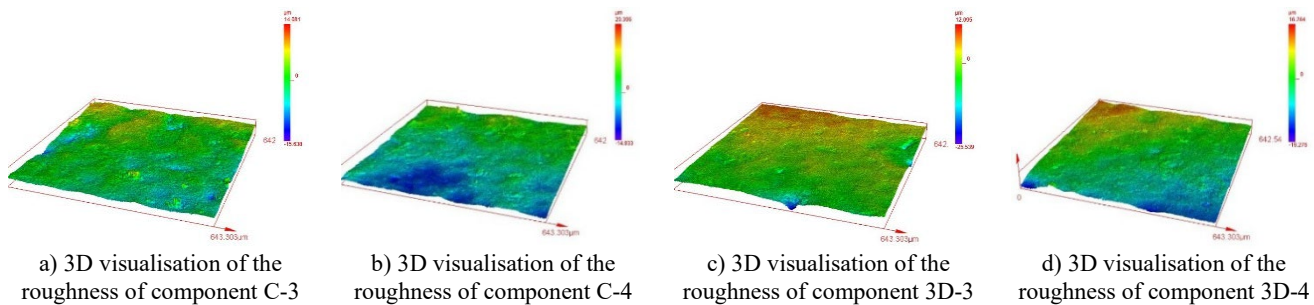
Figure 16 a–d show the 3D topography of the surface of the analysed components (C-3, C-4, 3D-3, and 3D-4) obtained using confocal microscopy. The colour scale expresses surface height differences from approximately  $-25 \mu\text{m}$  to  $+20 \mu\text{m}$ , depending on the specific sample. The average arithmetic roughness Ra reached values of  $1.28 \pm 0.24 \mu\text{m}$  for component C-3,  $1.56 \pm 0.21 \mu\text{m}$  for C-4,  $1.56 \pm 0.64 \mu\text{m}$  for 3D-3, and  $0.87 \pm 0.20 \mu\text{m}$  for 3D-4.

Fig. 16. Visualisation of component roughness

Conventionally manufactured components (C-3 and C-4) exhibited comparable levels of roughness, while additive component 3D-3 was characterised by greater surface variability, as evidenced by a larger standard deviation. In contrast, component

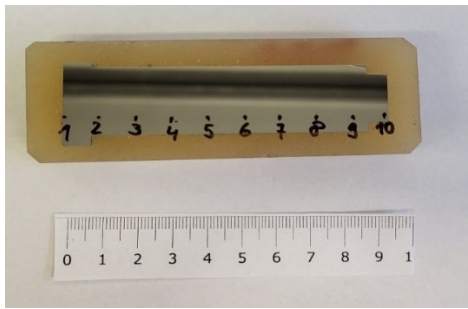
Measuring points numbered 1 to 10 were marked on the surface of the mounted and ground sample, as shown in Figure 17. Hardness testing was performed at these points using the Vickers method (HV10). The data obtained in this way was then converted into graphs showing the hardness curve from point 1 to point 10.

Fig. 17. View of the mounted and ground sample for hardness measurement

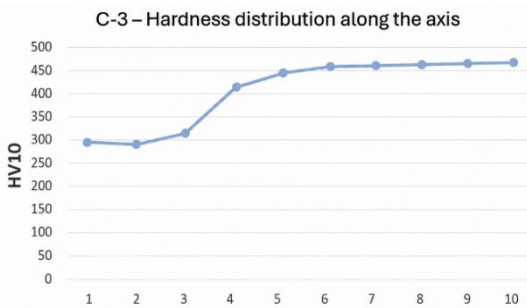
Figure 18 shows the hardness profile of component C-3 along its axis. At the beginning of the measurement (points 1–3), the hardness values are around 300 HV10 and show only a slight increase. From point 3 to point 4, there is a sharp increase in hardness from approximately 320 HV10 to more than 400 HV10. Subsequently, between points 4–6, the hardness continues to rise, but less significantly, and stabilises around 450 HV10. From point 6 to the end of the measurement (points 7–10), the hardness values remain relatively stable, with only minor fluctuations around 450 HV10. Overall, it is clear that the hardness along the axis increases gradually at the first measured points, then increases sharply and finally stabilises at a higher stable level. The lower hardness in the initial region and the subsequent increase may reflect local variations in thermal history; however, confirmation of the underlying cause would require direct microstructural analysis.

Fig. 18. Hardness development in component C-3

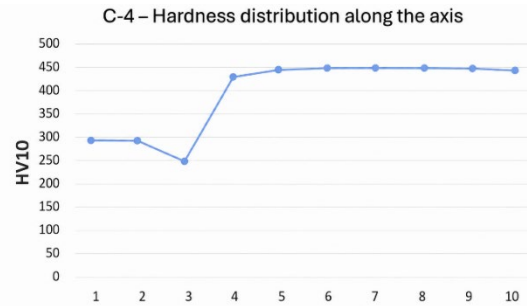
Figure 19 shows the hardness profile of component C-4 along its axis. At the first three measurement points, the hardness is around 300 HV10, with a slight decrease below this value between points 2 and 3. However, from point 3 to point 4, there is a sudden increase in hardness to more than 430 HV10. From this point on, the hardness stabilises and remains at a constant level of around 440–450 HV10 for the remaining measurements (points 4–10),

with minimal fluctuation. This observation indicates that the initial region of the sample exhibits lower hardness. The subsequent increase and stabilisation from point 4 onwards may reflect local variations in thermal history or heat-treatment response; however, confirmation of the underlying cause would require direct microstructural analysis.

Fig. 19. Hardness development in component C-4

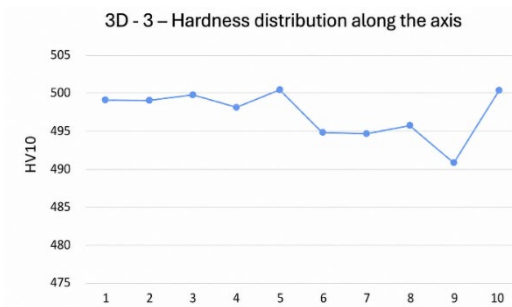
Figure 20 shows the hardness profile of component 3D-3 along its axis. The hardness at all the measured points falls within a narrow range of approximately 492–502 HV10. At the beginning (points 1–3), the values are very stable at around 499–500 HV10. Subsequently, at points 4 and 5, there are minor fluctuations, but the values remain close to 500 HV10. From point 6, the hardness decreases slightly and reaches a minimum of approximately 492 HV10 around point 9. At the last measured point (10), however, it rises sharply again and returns to a level around 501 HV10. Overall, the hardness of component 3D-3 was relatively uniform along the measured axis, with only minor local fluctuations. This trend indicates a relatively uniform hardness distribution and stable mechanical response.

Fig. 20. Hardness development in component 3D-3

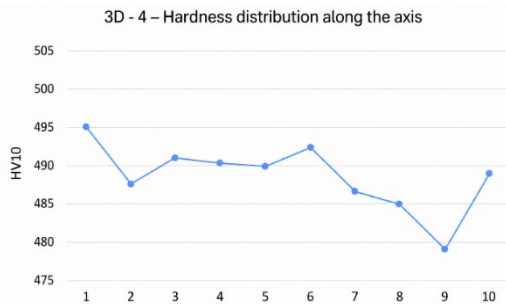
Figure 21 shows the hardness profile of component 3D-4 along its axis. The hardness ranges from approximately 481 to 495 HV10. At the beginning (point 1), the value is higher, around 495 HV10; then there is a slight decrease, and between points 2–5, the hardness remains stable at around 489–491 HV10. At point 6, the value increases slightly again, but from point 7 it gradually decreases to a minimum of around 481 HV10 at point 9. At the final point (10), there is a partial compensation, and the hardness returns to a value of around 490 HV10. Overall, the hardness of sample 3D-4 was relatively uniform along the measured axis, although minor

fluctuations and a gradual decrease towards point 9 were observed. These variations may reflect local differences in thermal history or heat-treatment response; however, confirmation of their origin would require direct microstructural analysis.

Fig. 21. Hardness development in component 3D-4
